2009-Efectis-R0104(E)

Determination of the resistance to fire according to
EN 1365-2:1999 of a floor construction consisting
of wooden beams with a Lewis® floor on top.
Anticipated fire resistance : 90 minutes

Date	March 2009
Author(s)	P.W.M. Kortekaas Ing. P.G.R. Scholten
Number of pages	9 (excluding appendices)
Number of appendices	3 (A to C)
Sponsor	Reppel B.V. p.o. box 102 3300 AC Dordrecht The Netherlands
Project name	Resistance to fire of a wooden floor ceiling construction
Project number	2008770

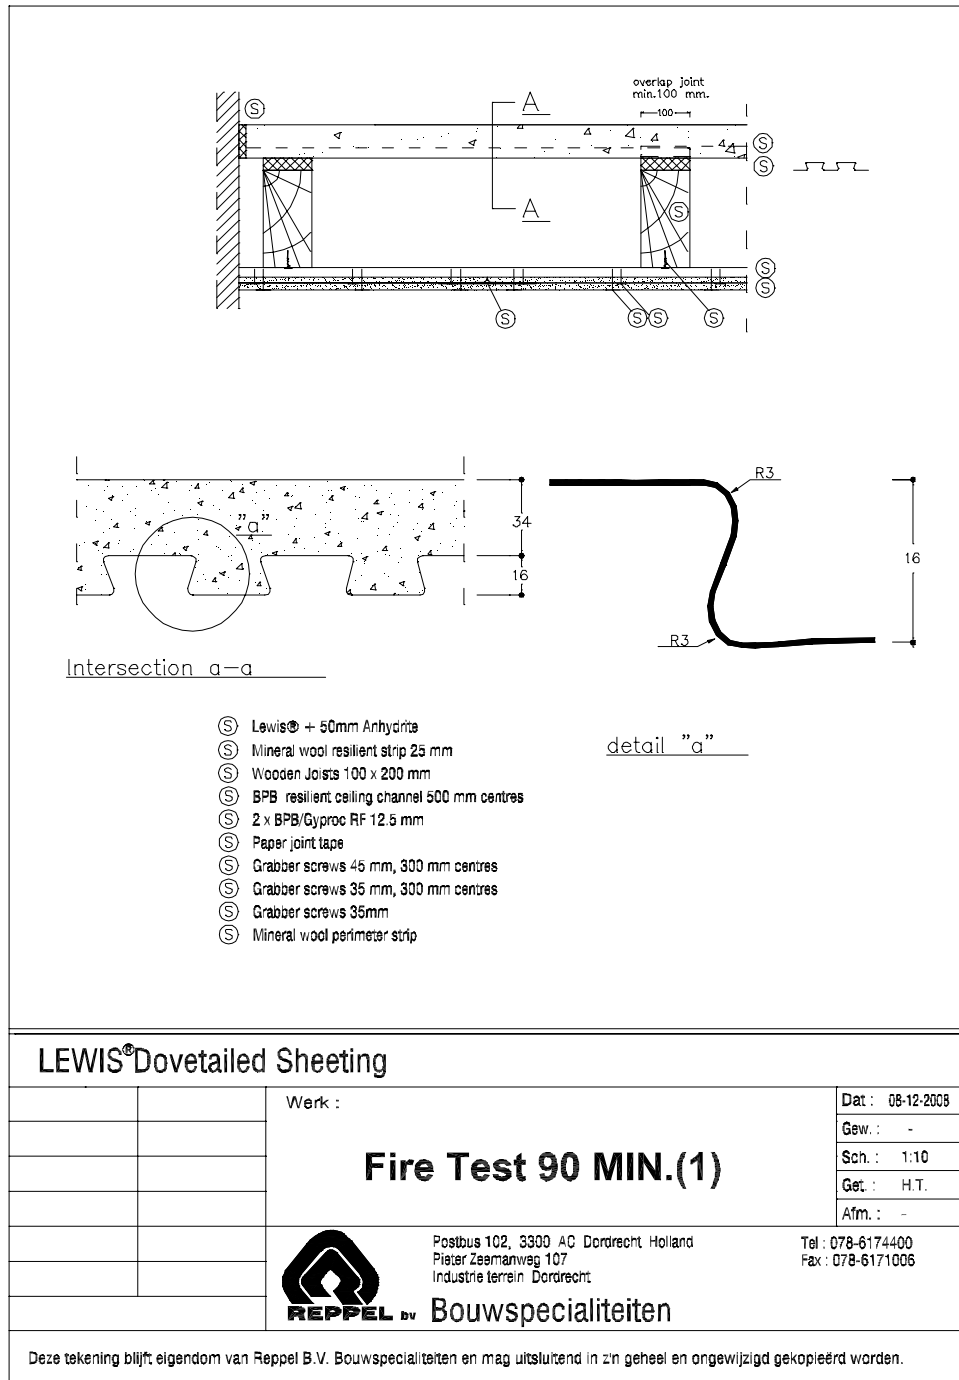
Figure 1: overview of the test specimen

Investigated was a wooden floor construction.
For details we refer to figure 1 and the description mentioned below.

- Material : Pinewood
- Cross section : 100 x 200 mm
- Centre-to-centre distance : 500 mm
- Span : 4150 mm

- Type : BPB resilient ceiling channel
- Centre-to-centre distance : 500 mm
- Fixing : grabber screws 25 mm, 2 per beam

- Type : BPB Gyproc RF 12.5 mm
- Thickness : 12.5 mm
- Number of layers : 2
- Fixing : 1st layer grabber screws 35 mm, c.t.c. distance 300 mm;
2nd layer grabber screws 45 mm, c.t.c. distance 300 mm;
- Joints : covered with paper tape and covered with BPB Promix Premium joint mortar

- Type : Lewis plates
- Overlap between plates : min. 100 mm
- Fixing : the Lewis plates are joint together by self tapping screws Ø 4.2 x 16 mm. The floor is not connected to the wooden beams
- Support : between the Lewis plates and the top of the wooden beams Rockwool of 25 mm thick and 100 mm wide

- Type : anhydrite
- Thickness : 50 mm (34 mm over the top of the Lewis plates)

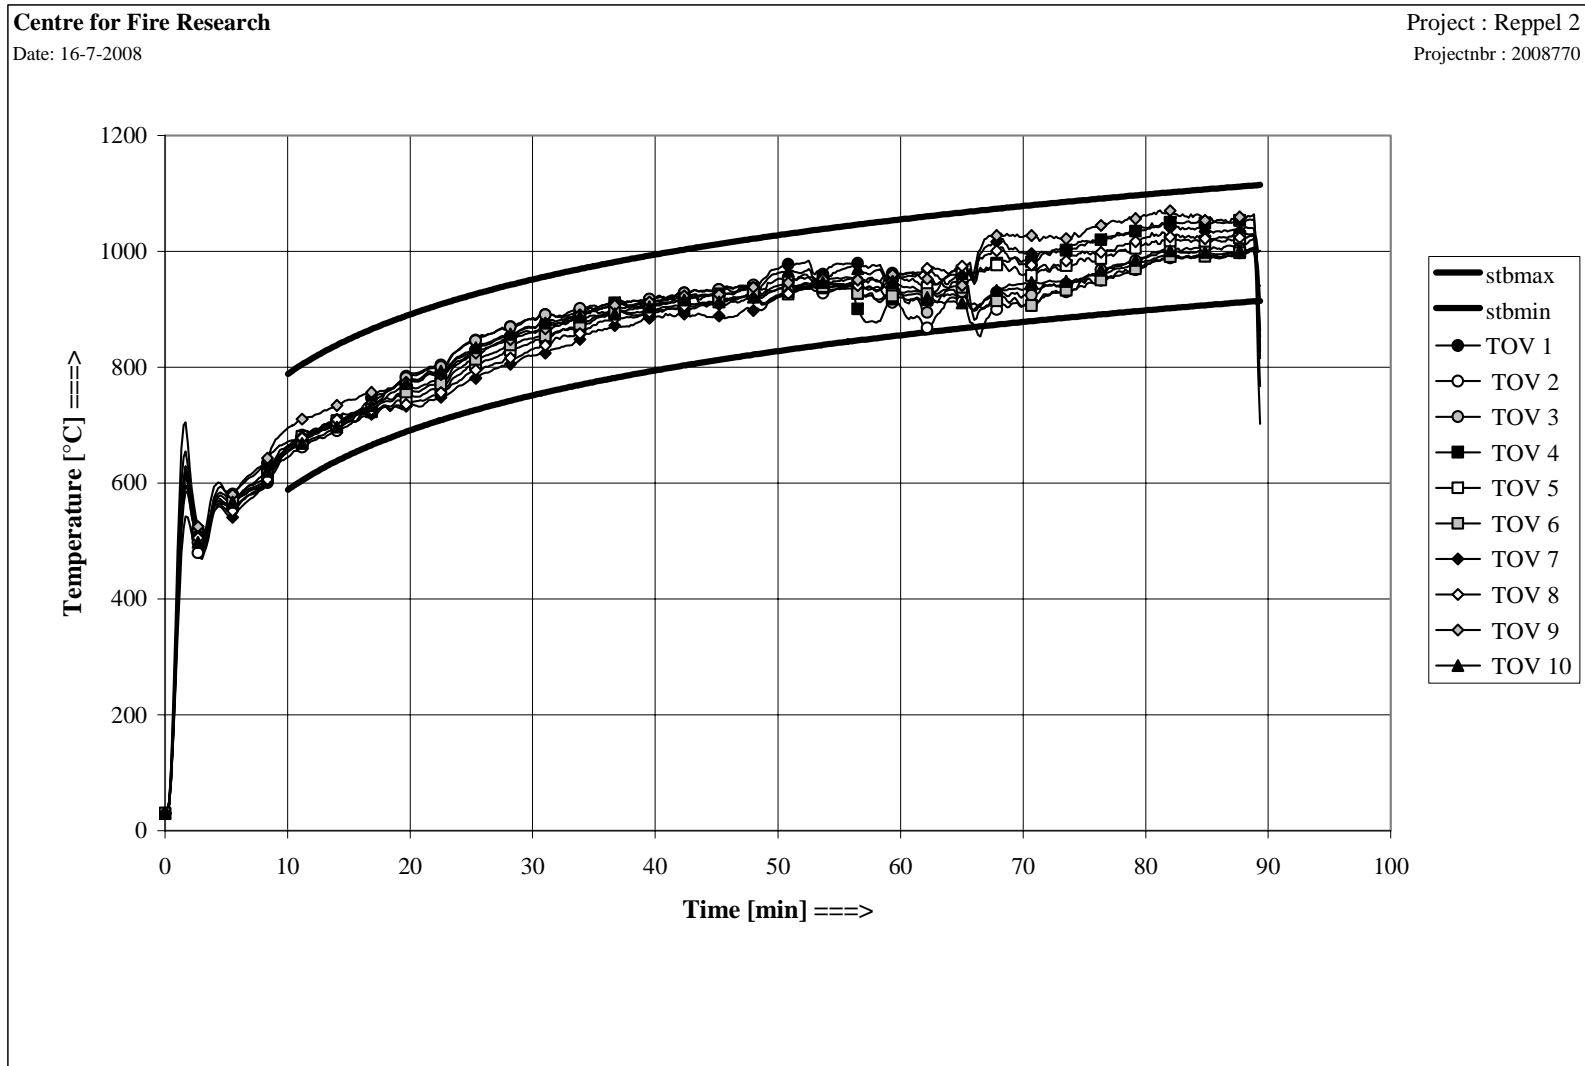
Figure A1 : measured gas temperatures in the furnace

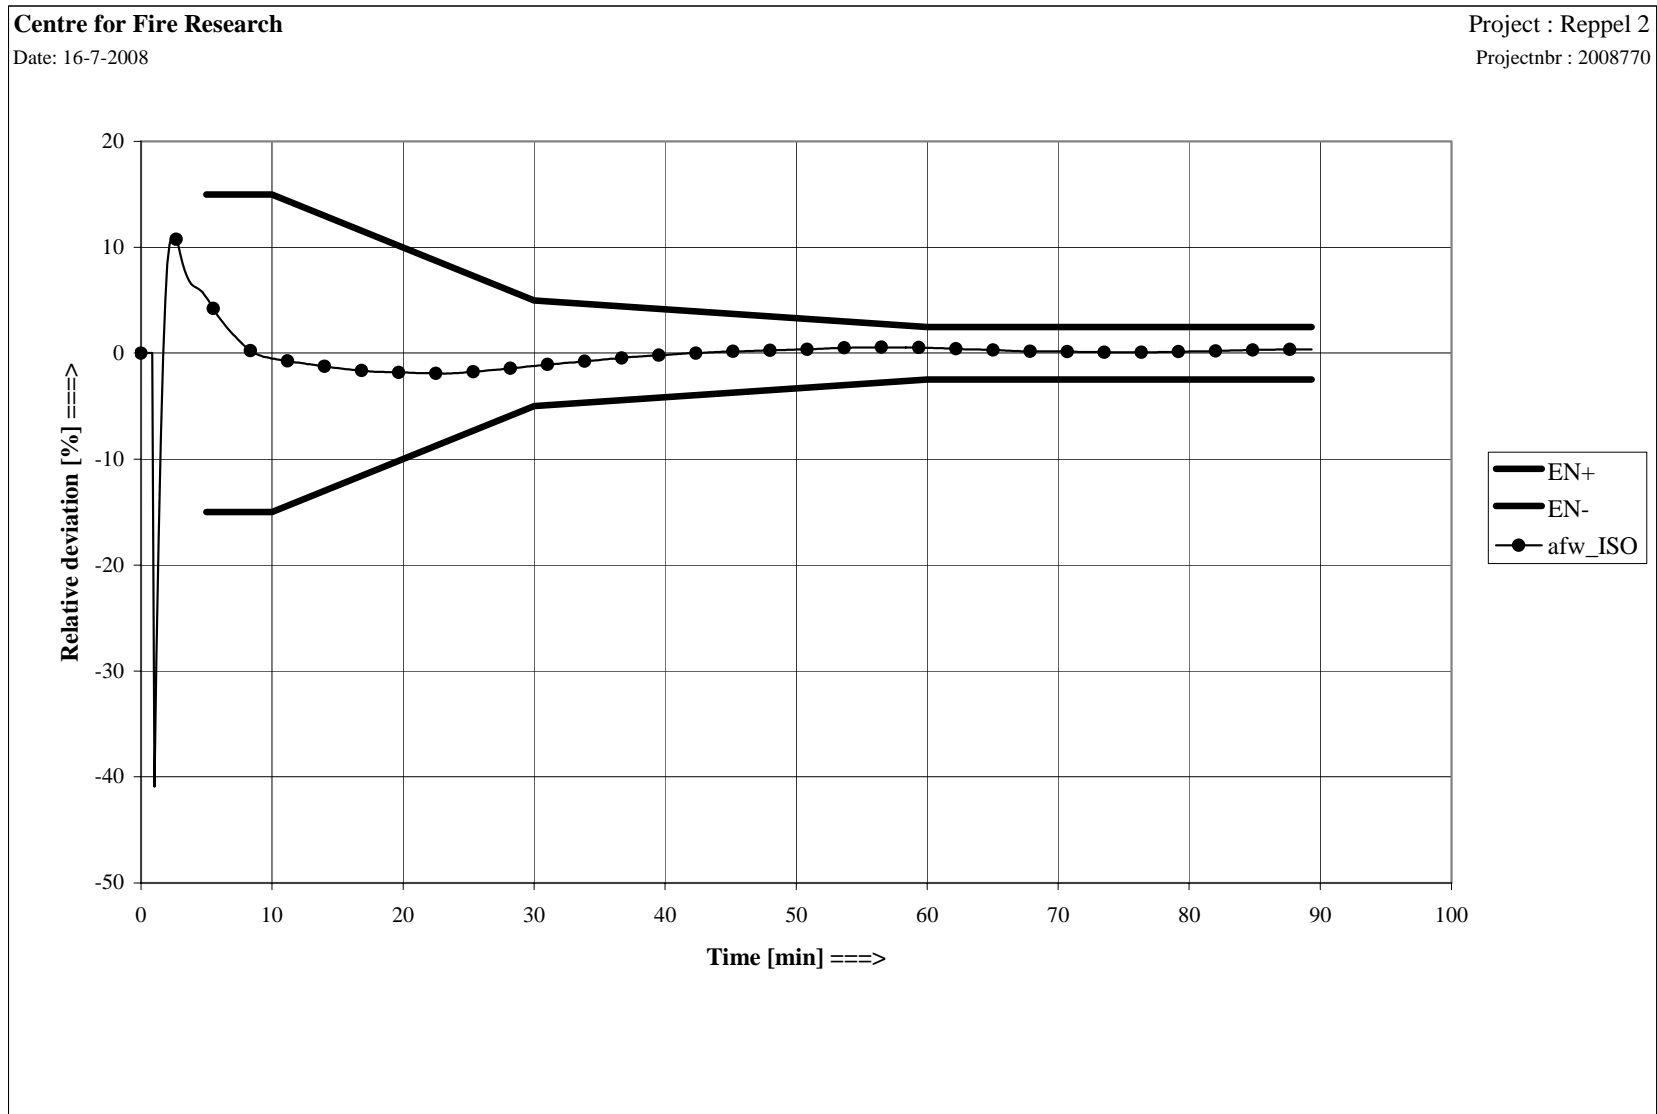
Figure A2 : relative deviation of the furnace temperatures

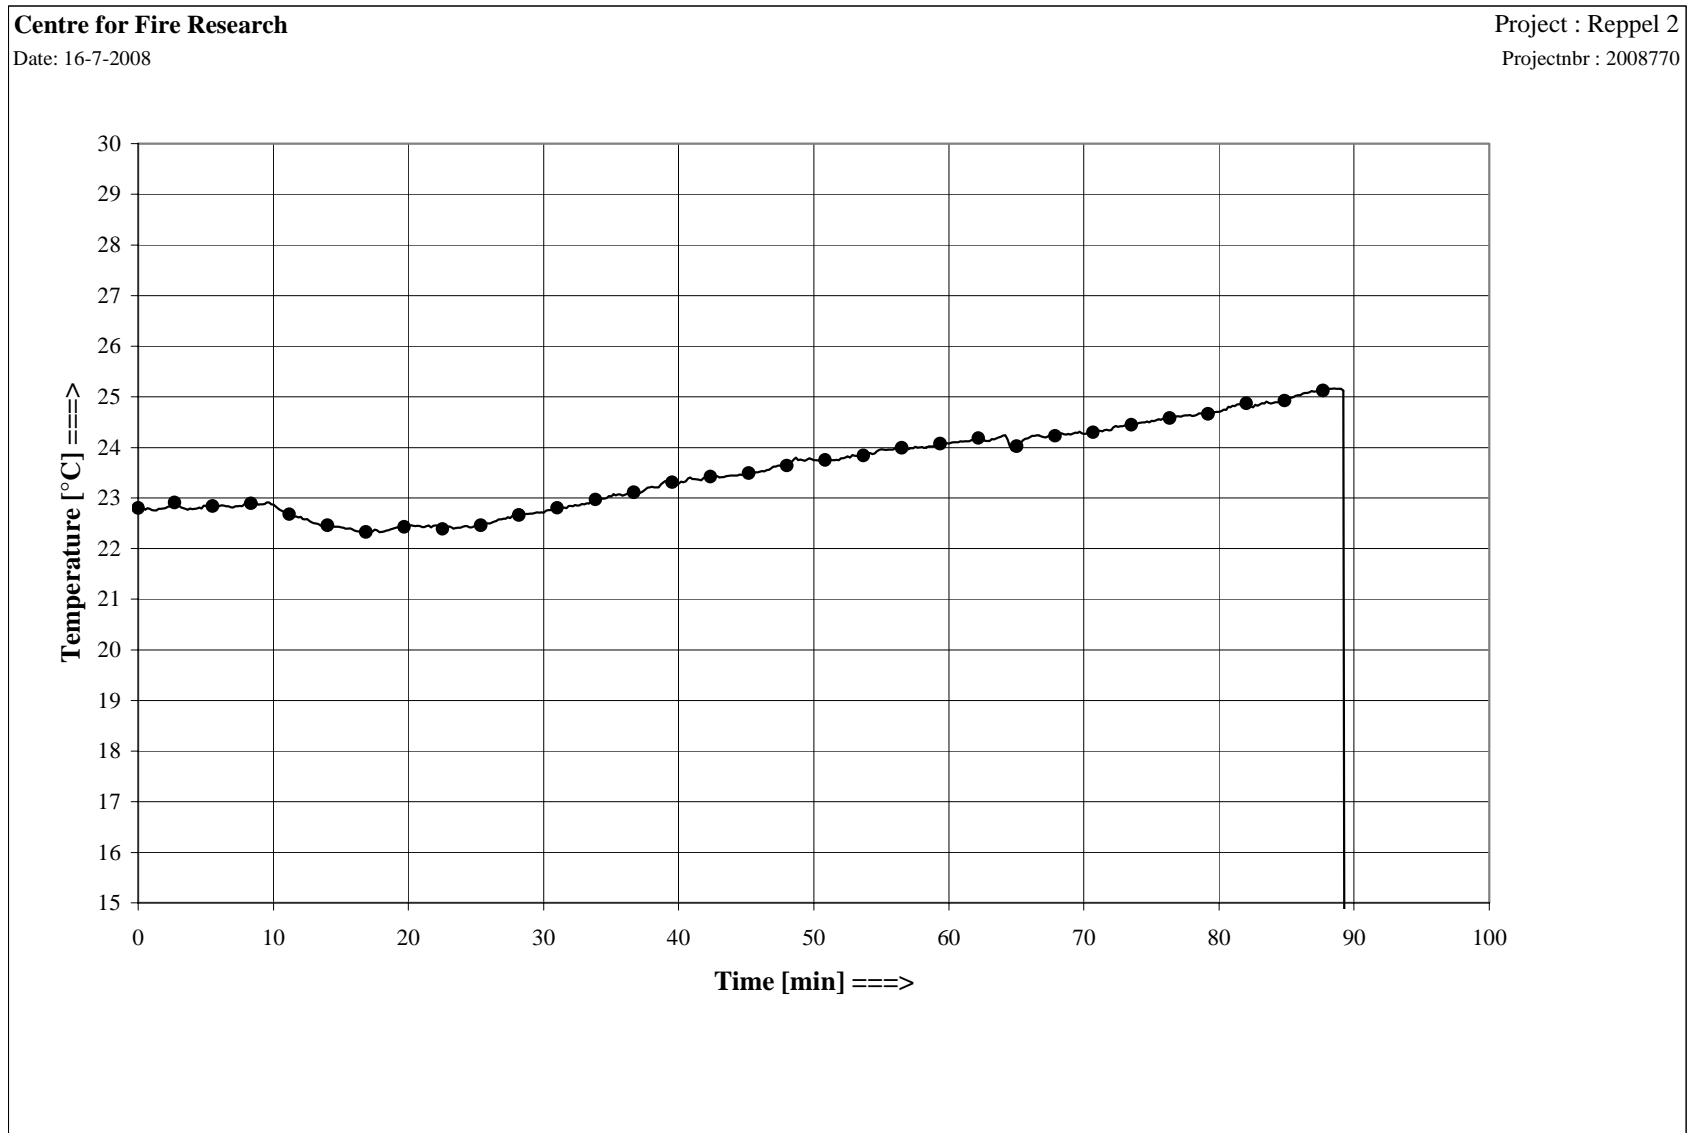
Figure A3 : ambient temperature in the laboratory during the test

During heating the temperature and the air speed in the laboratory fulfilled the criteria of EN 1363-1:1999.

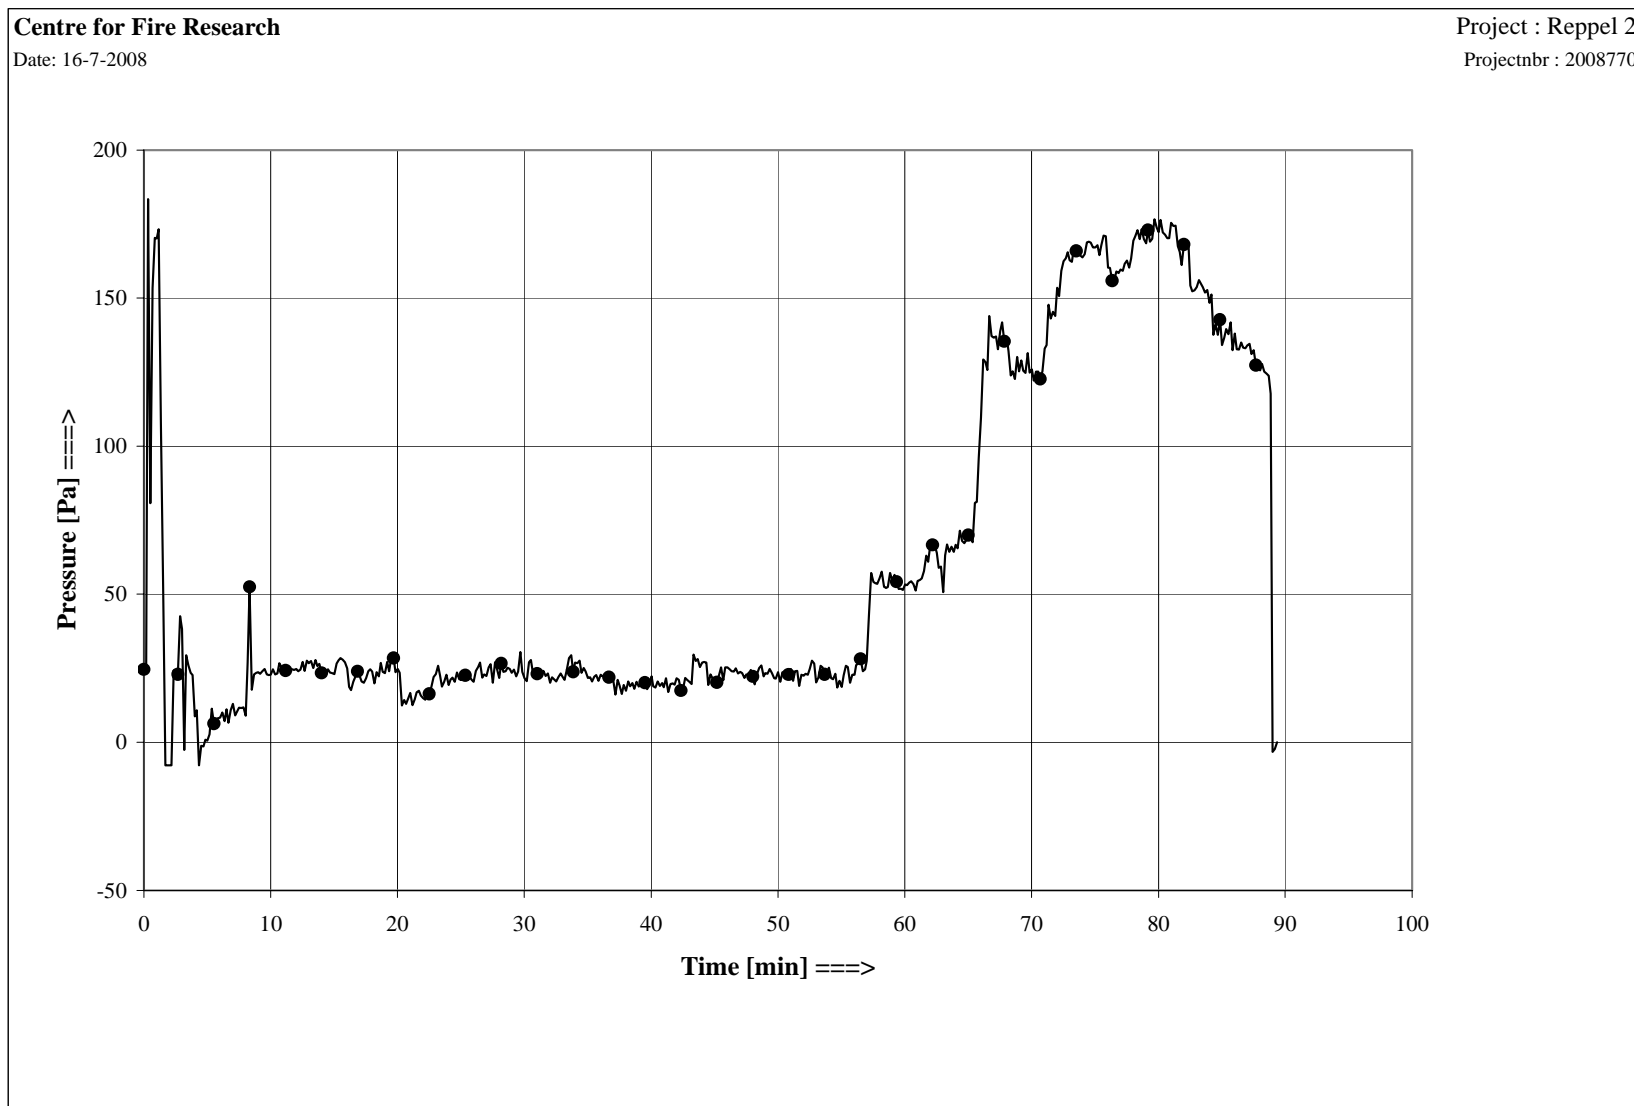
Figure A4 : measured pressure in the furnace

The test specimen was heated on one side using the standard fire curve.
The pressure in the furnace that was aimed for was 20 Pa at 100 mm below the floor construction.

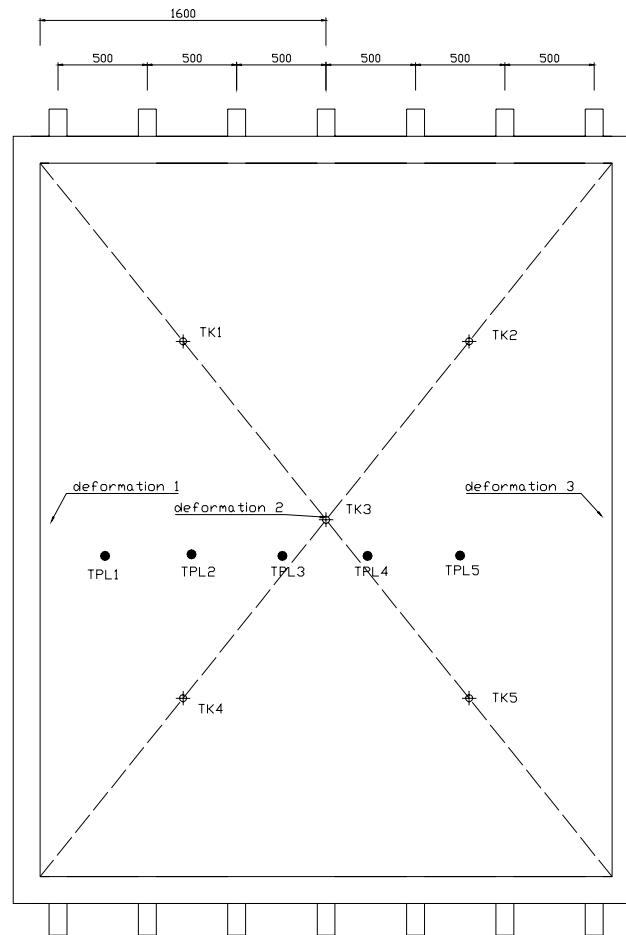
TK1-5 are thermocouples on the concrete floor
TPL1-5 are thermocouples in the plenum between the wooden beams

Figure B1: Positions of the thermocouples

The thermocouple positions are given in figure B1.

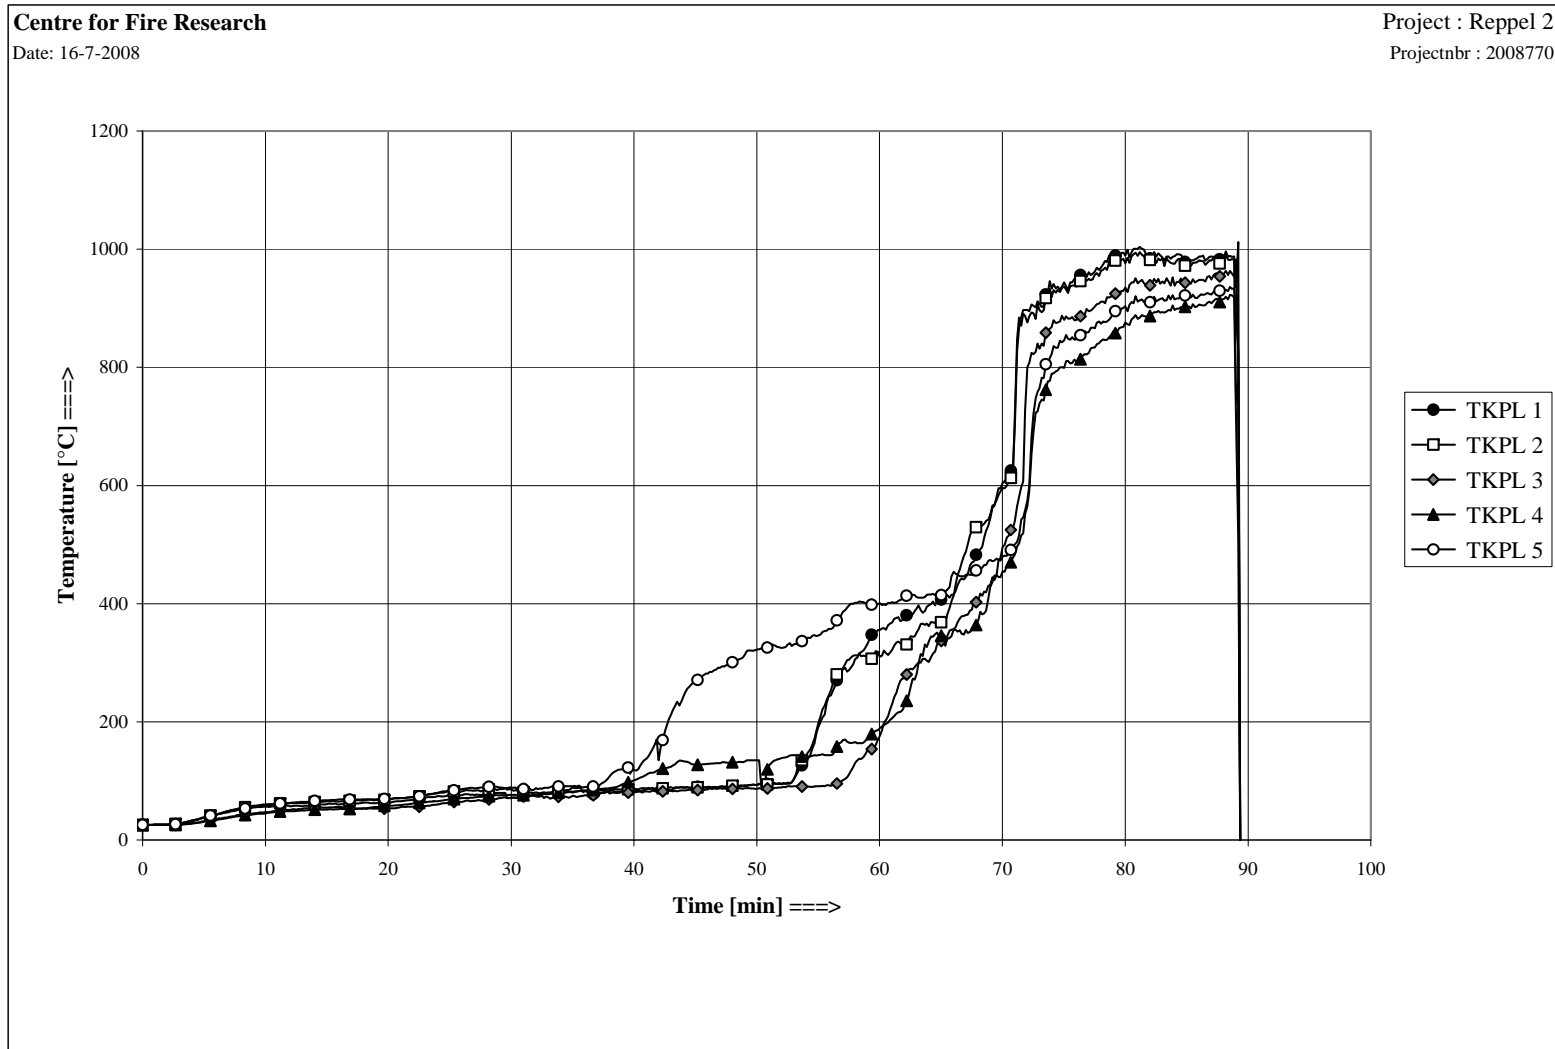
Figure B2: measured air temperatures in the plenum

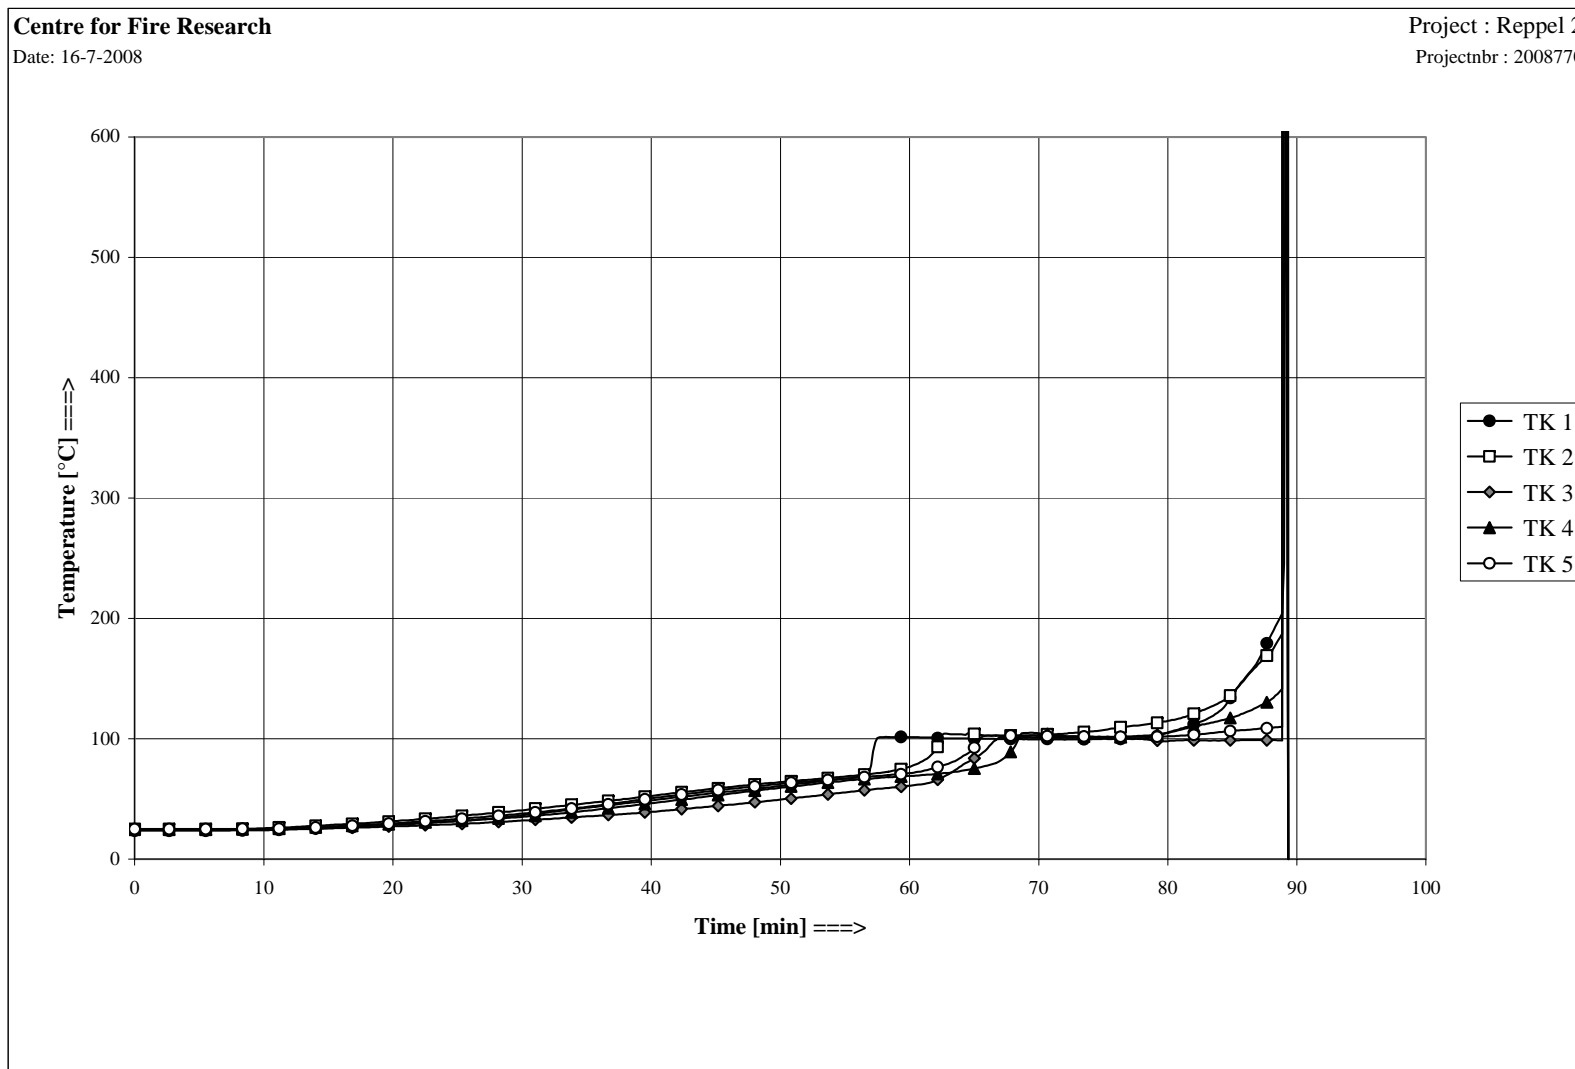
Figure B3: measured surface temperatures on top of the floor

Time [min.]	Observations
0	Start of heating
4	Paper tape falls from the joints
23	1 st gypsum board in the middle starts to deform
25	2 nd gypsum board at the back starts to collapse
30	1 st gypsum board at the back starts to collapse
43	Gypsum board on front left collapses
50	Most of the gypsum boards from the first layer have collapsed
53	2 nd layer of gypsum board collapsed at two places
62	Fire is intensifying
88	Temperature rise 180°C at thermocouple 9
89	Floor has collapsed, end of heating

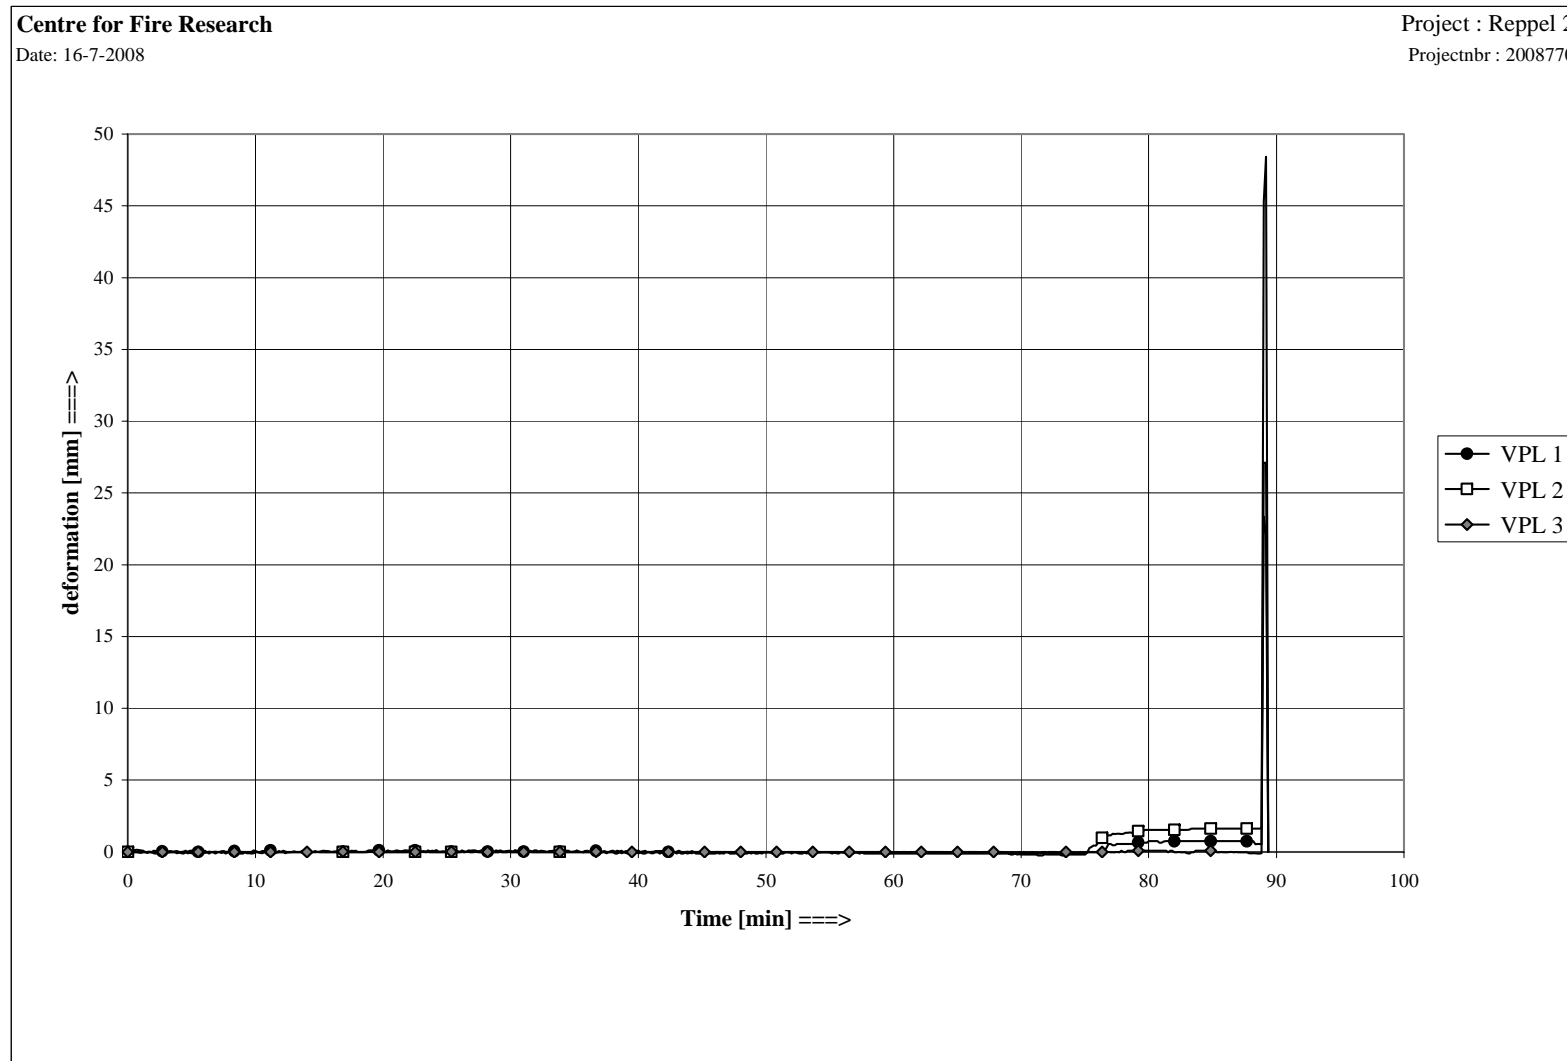
Figure B4: measured deformation of the floor

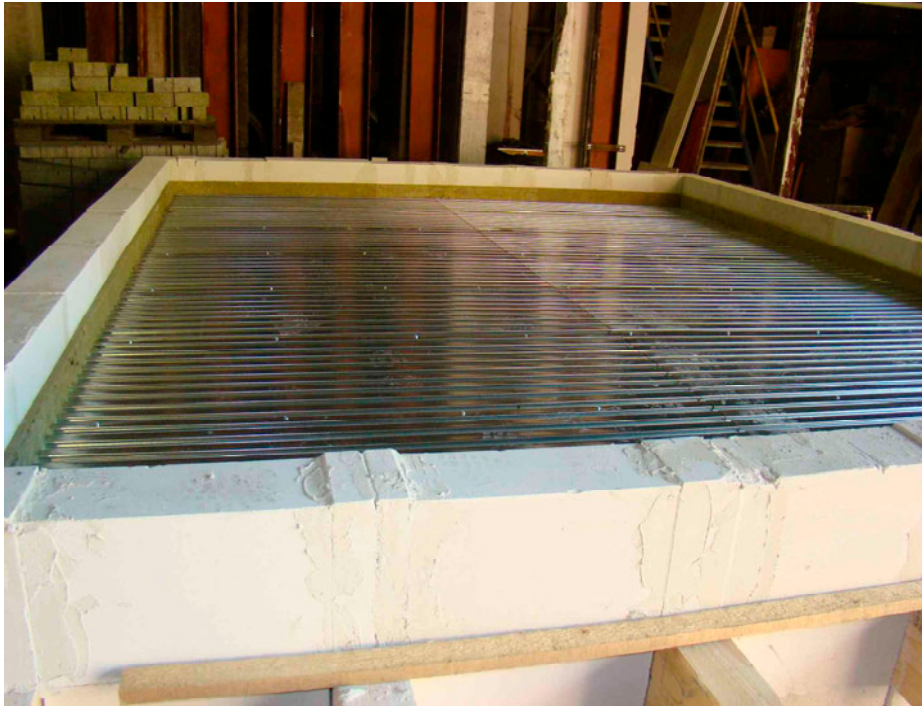
Photo 1: view of the floor before casting the concrete

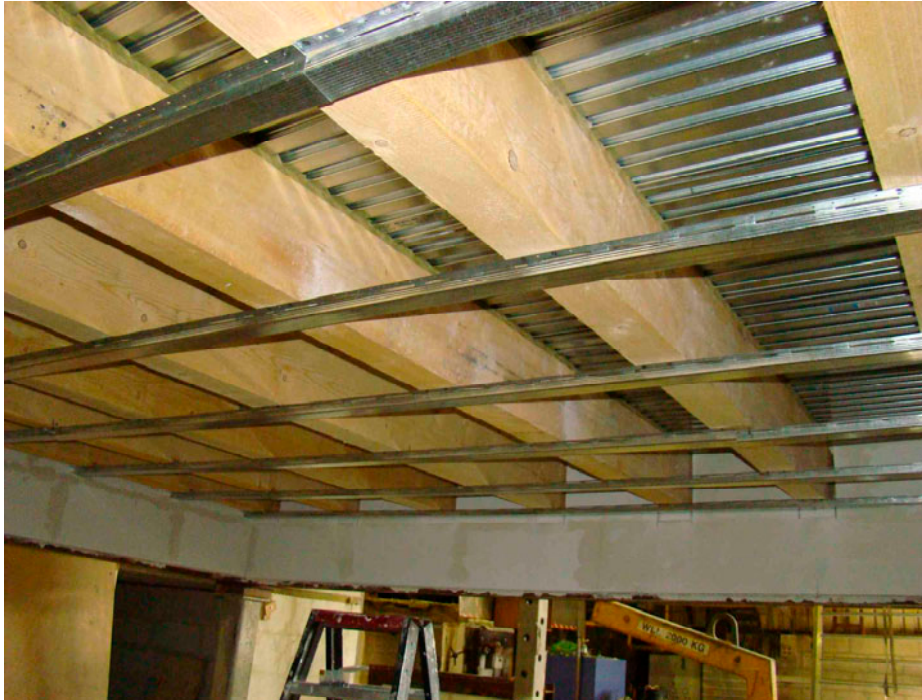
Photo 2 : detail of the mounting of the ceiling channels

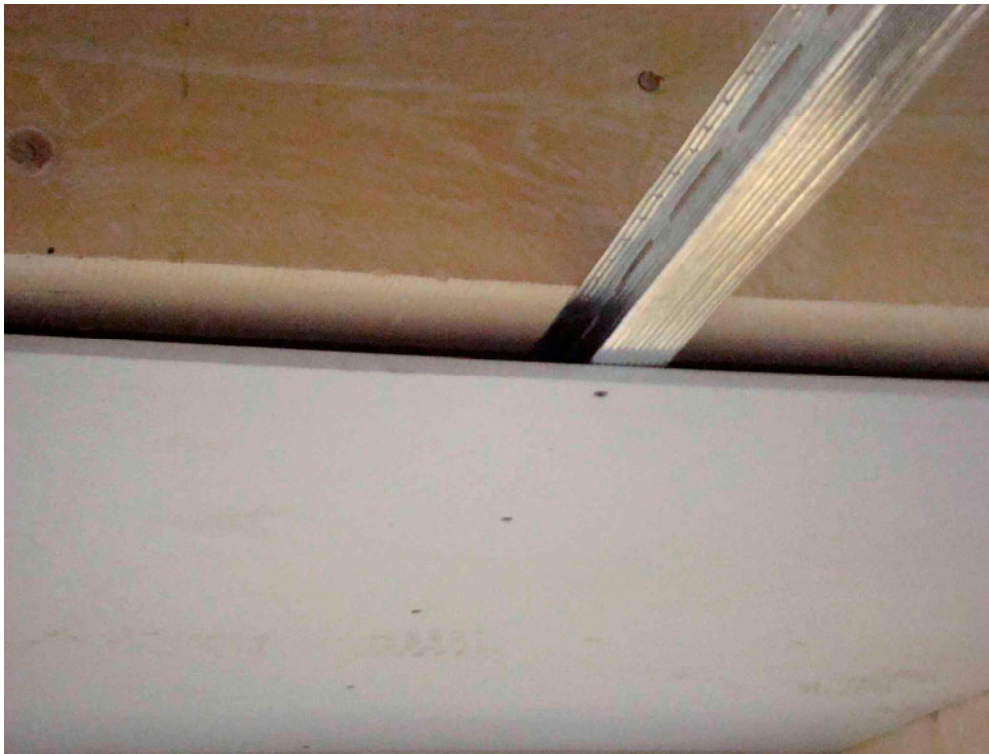
Photo 3 : detail of the mounting of the gypsum boards

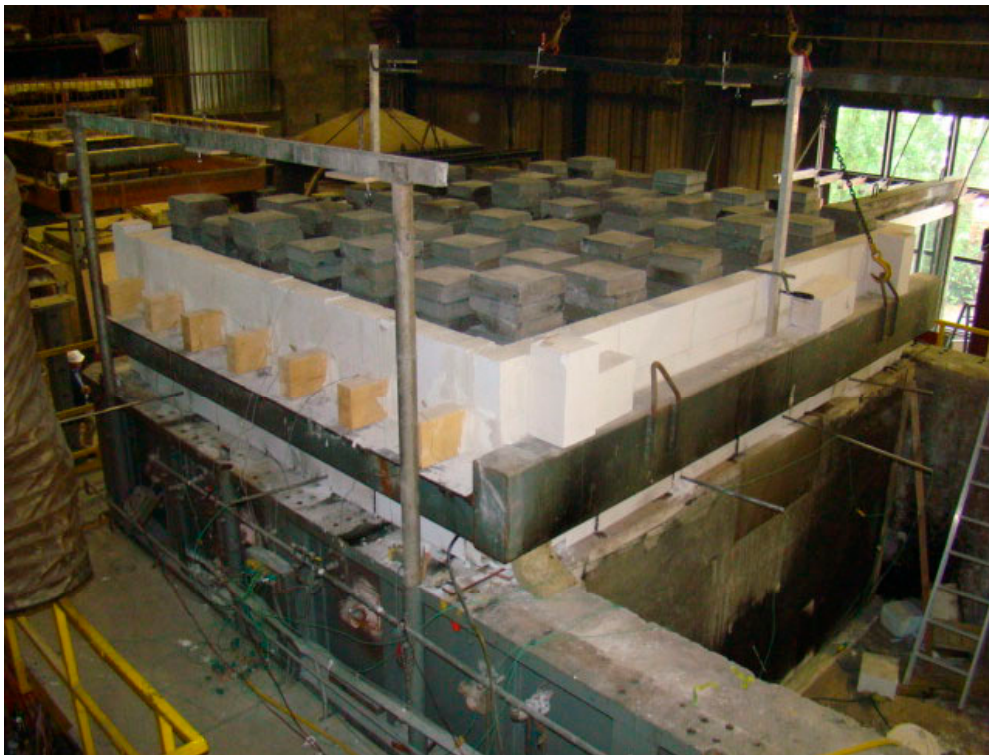
Photo 4 : view of the construction before the test
