**Efectis Nederland report**

**2009-Efectis-R0105(E)**

Determination of the resistance to fire according to  
EN 1365-2:1999 of a floor construction consisting  
of wooden beams with a Lewis® floor on top.  
Anticipated fire resistance : 90 minutes

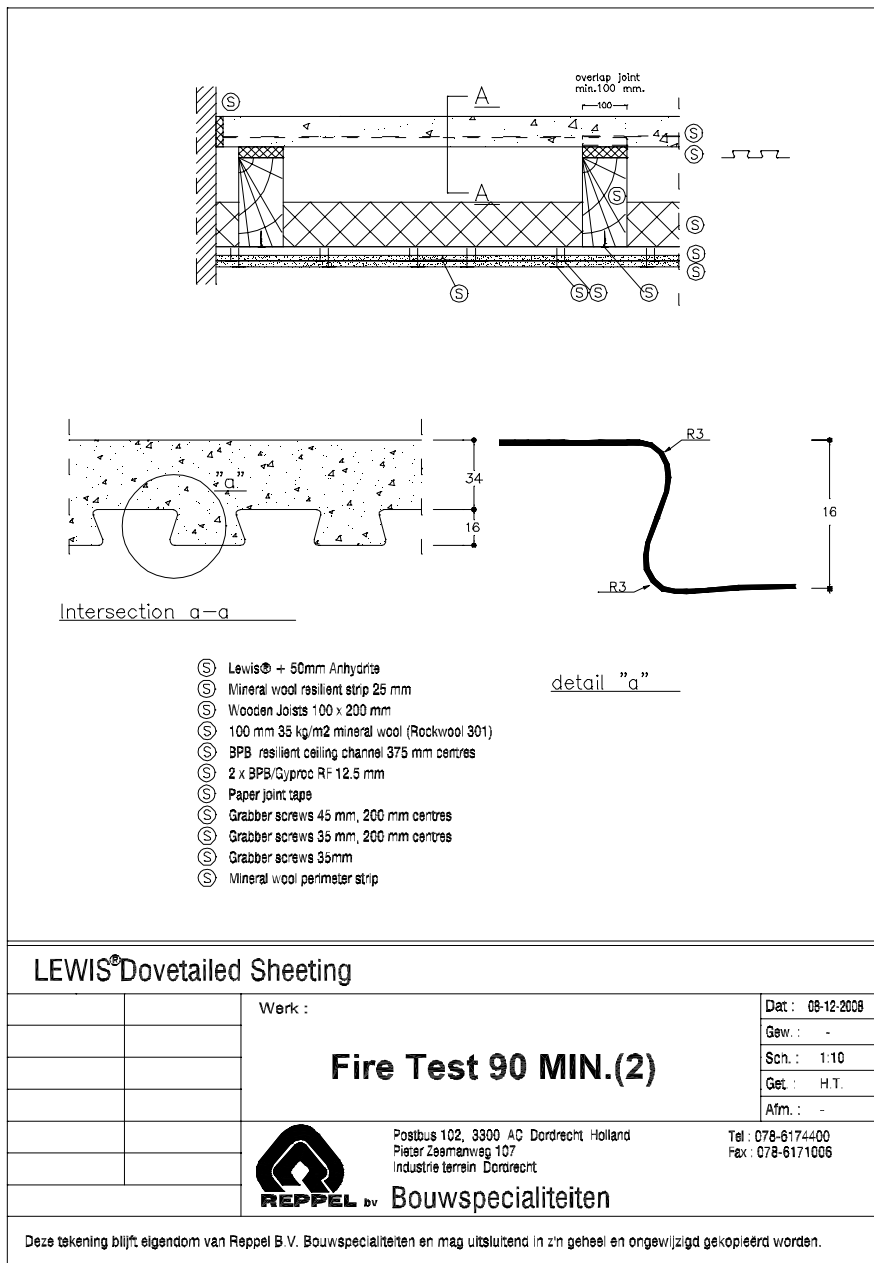
Figure 1: overview of the test specimen

Investigated was a wooden floor construction  
For details we refer to figure 1 and the description mentioned below.

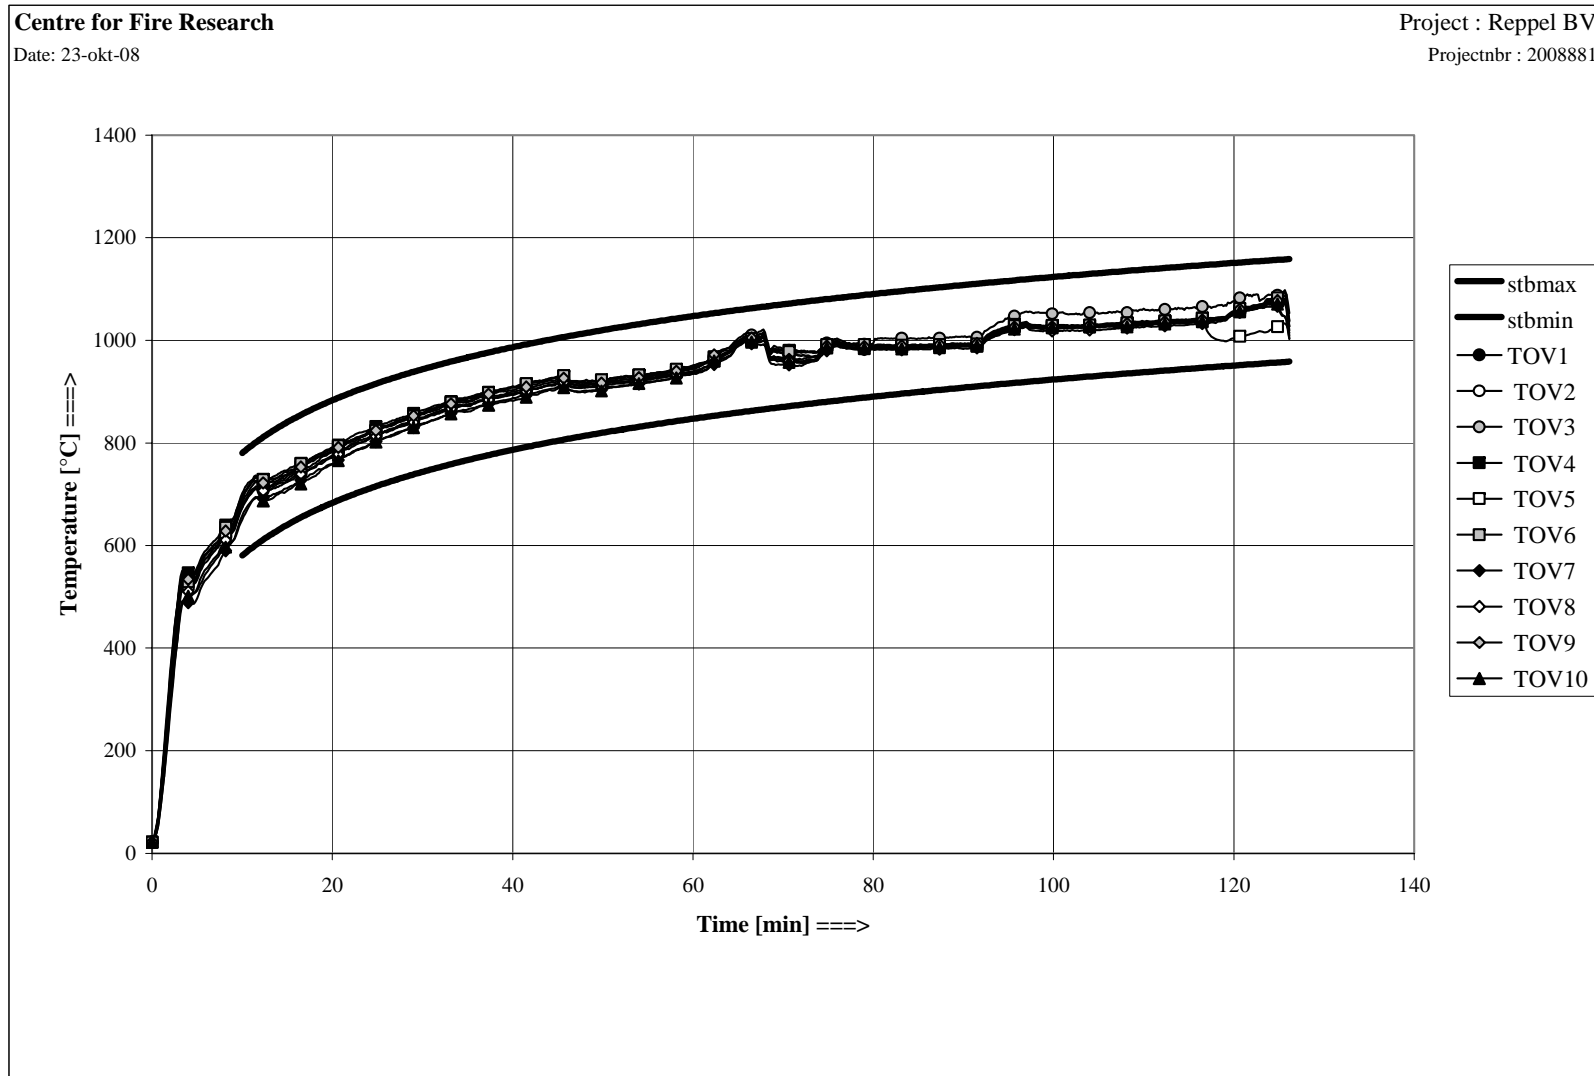
Figure A1 : measured gas temperatures in the furnace

Figure A1    :    measured gas temperatures in the furnace

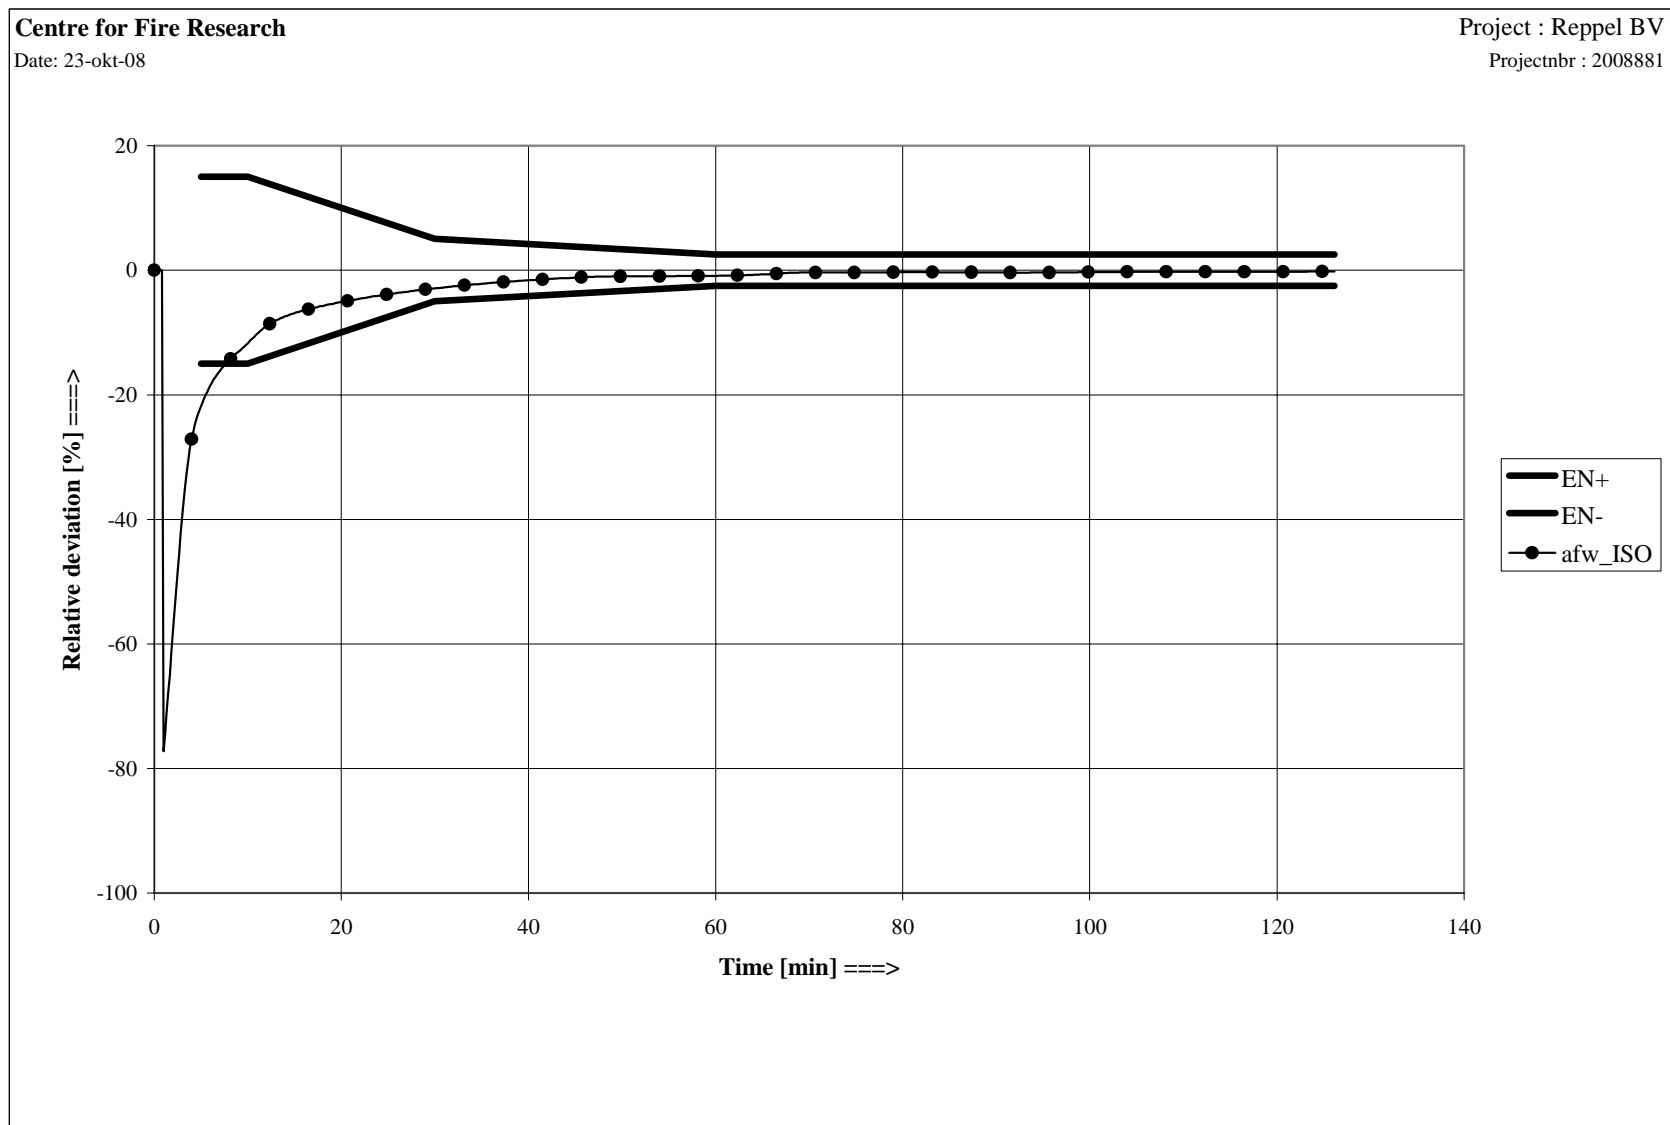
Figure A2 : relative deviation of the furnace temperatures

Figure A2    :    relative deviation of the furnace temperatures

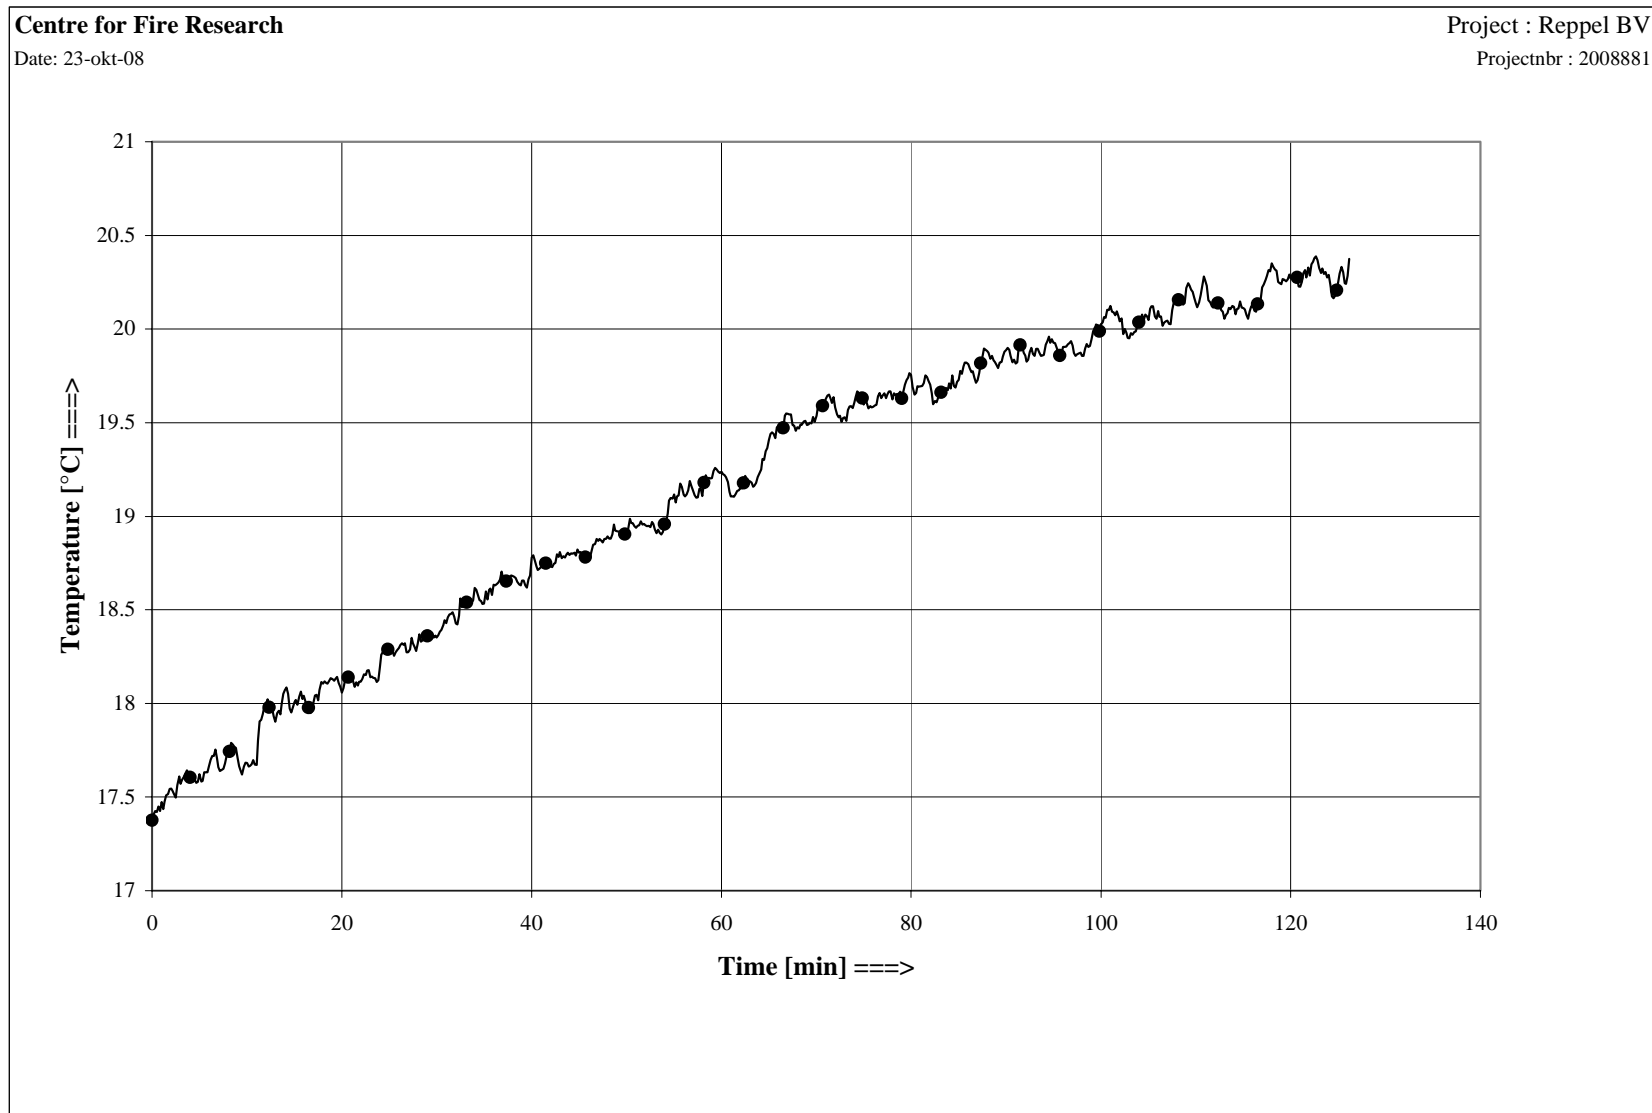
Figure A3 : ambient temperature in the laboratory during the test

Figure A3    :    ambient temperature in the laboratory during the test

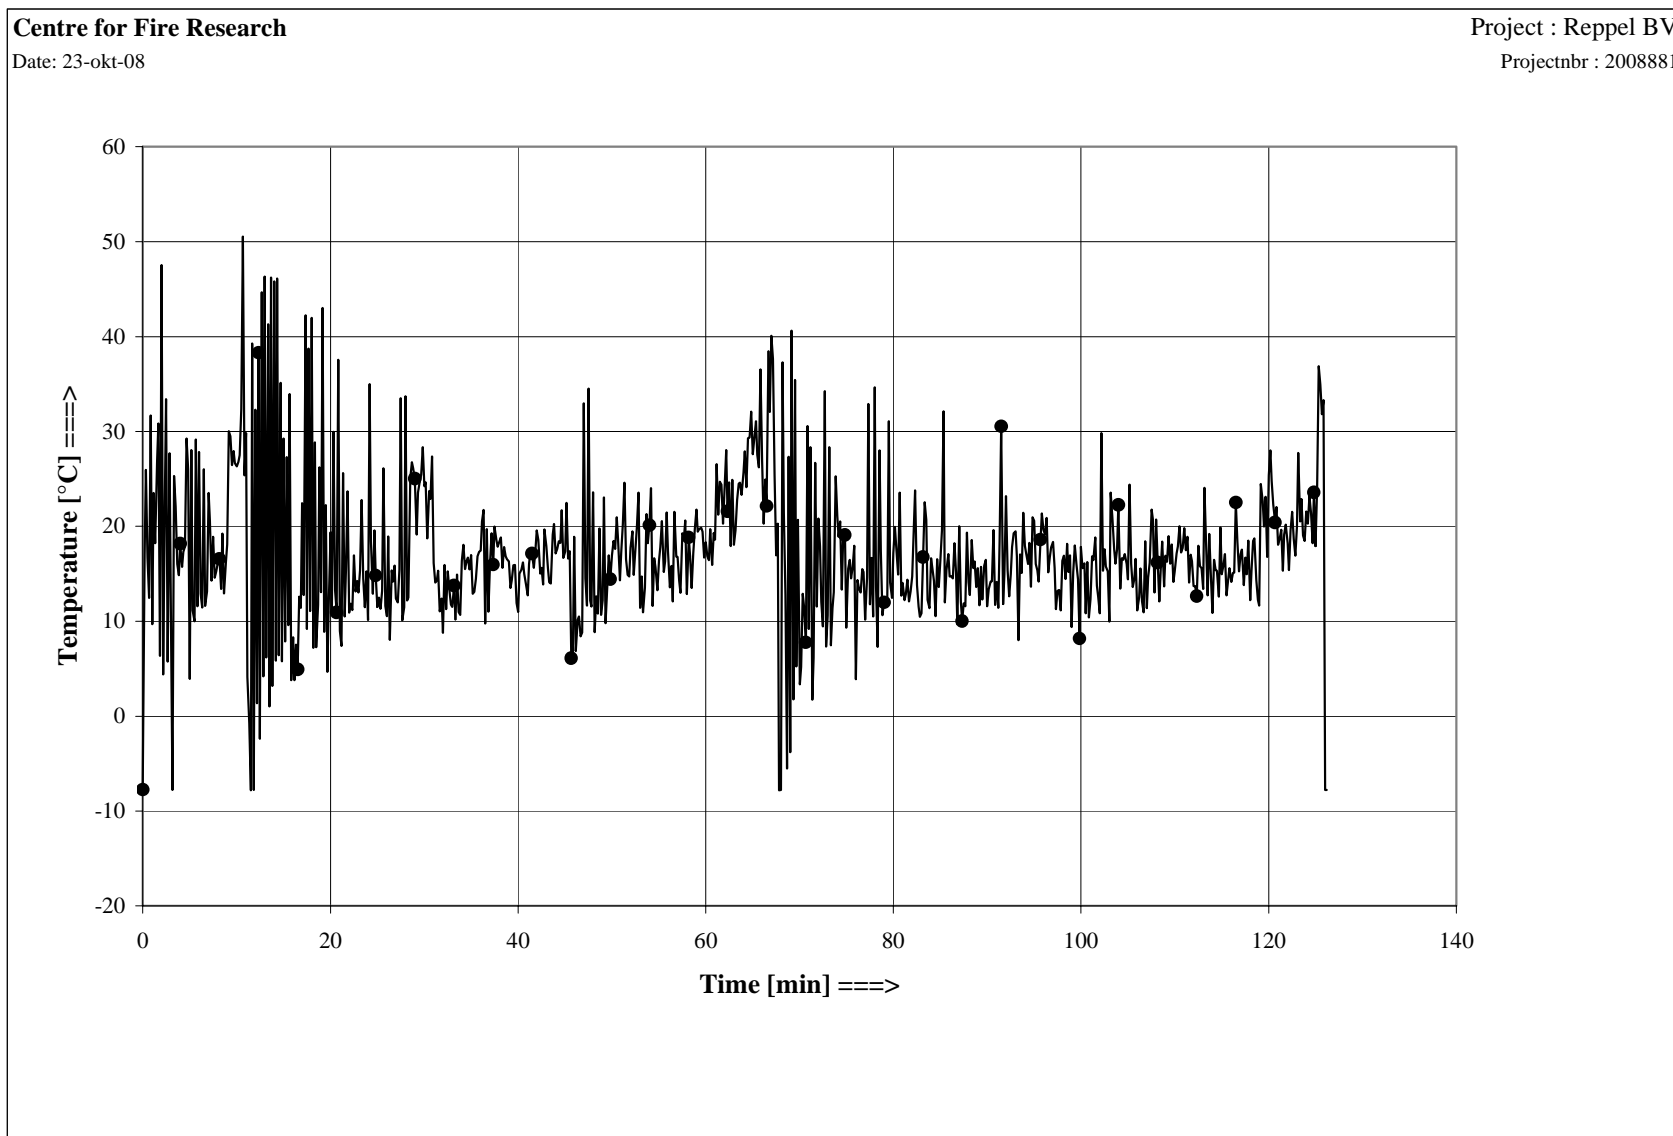
Figure A4 : measured pressure in the furnace

The pressure in the furnace varied during the test. This was partly caused by the burning of the wooden beams after 1 hour of heating. Before one hour the variations were caused because a pressure meter with a large span was used. Because of this the measurements are less accurate. The graph with the relative deviation shows that the bottom limit line is just hit. This was caused by the furnace operator who failed to follow the required curve. Both the variation in pressure en the relative deviation did not have a significant influence on the result because the test represented slightly more severe conditions.

Figure A4    :    measured pressure in the furnace

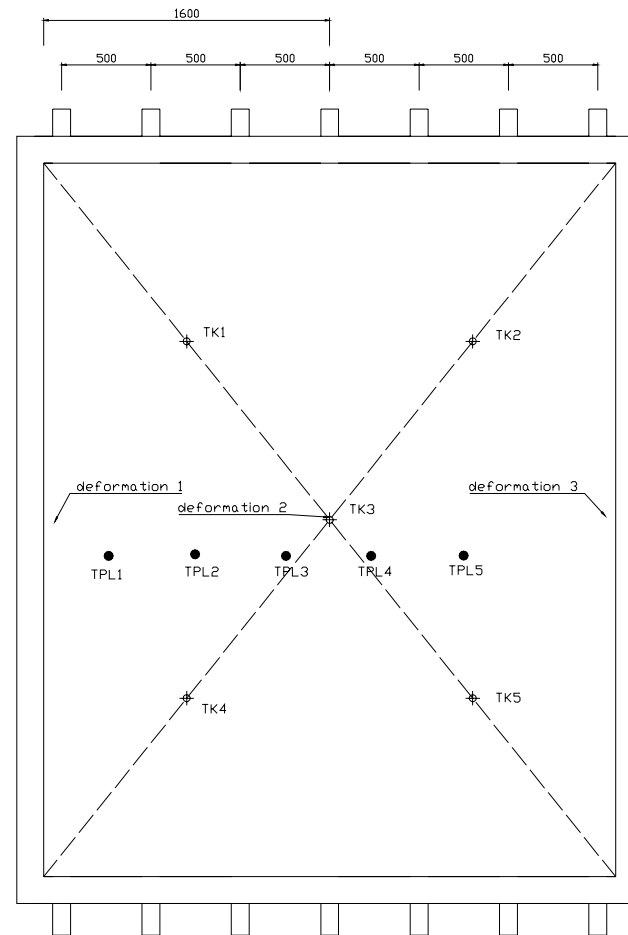
TK1-5 are thermocouples on the concrete floor  
TPL1-5 are thermocouples in the plenum between the wooden beams

Figure B1: Positions of the thermocouples

Figure B1: positions of the thermocouples

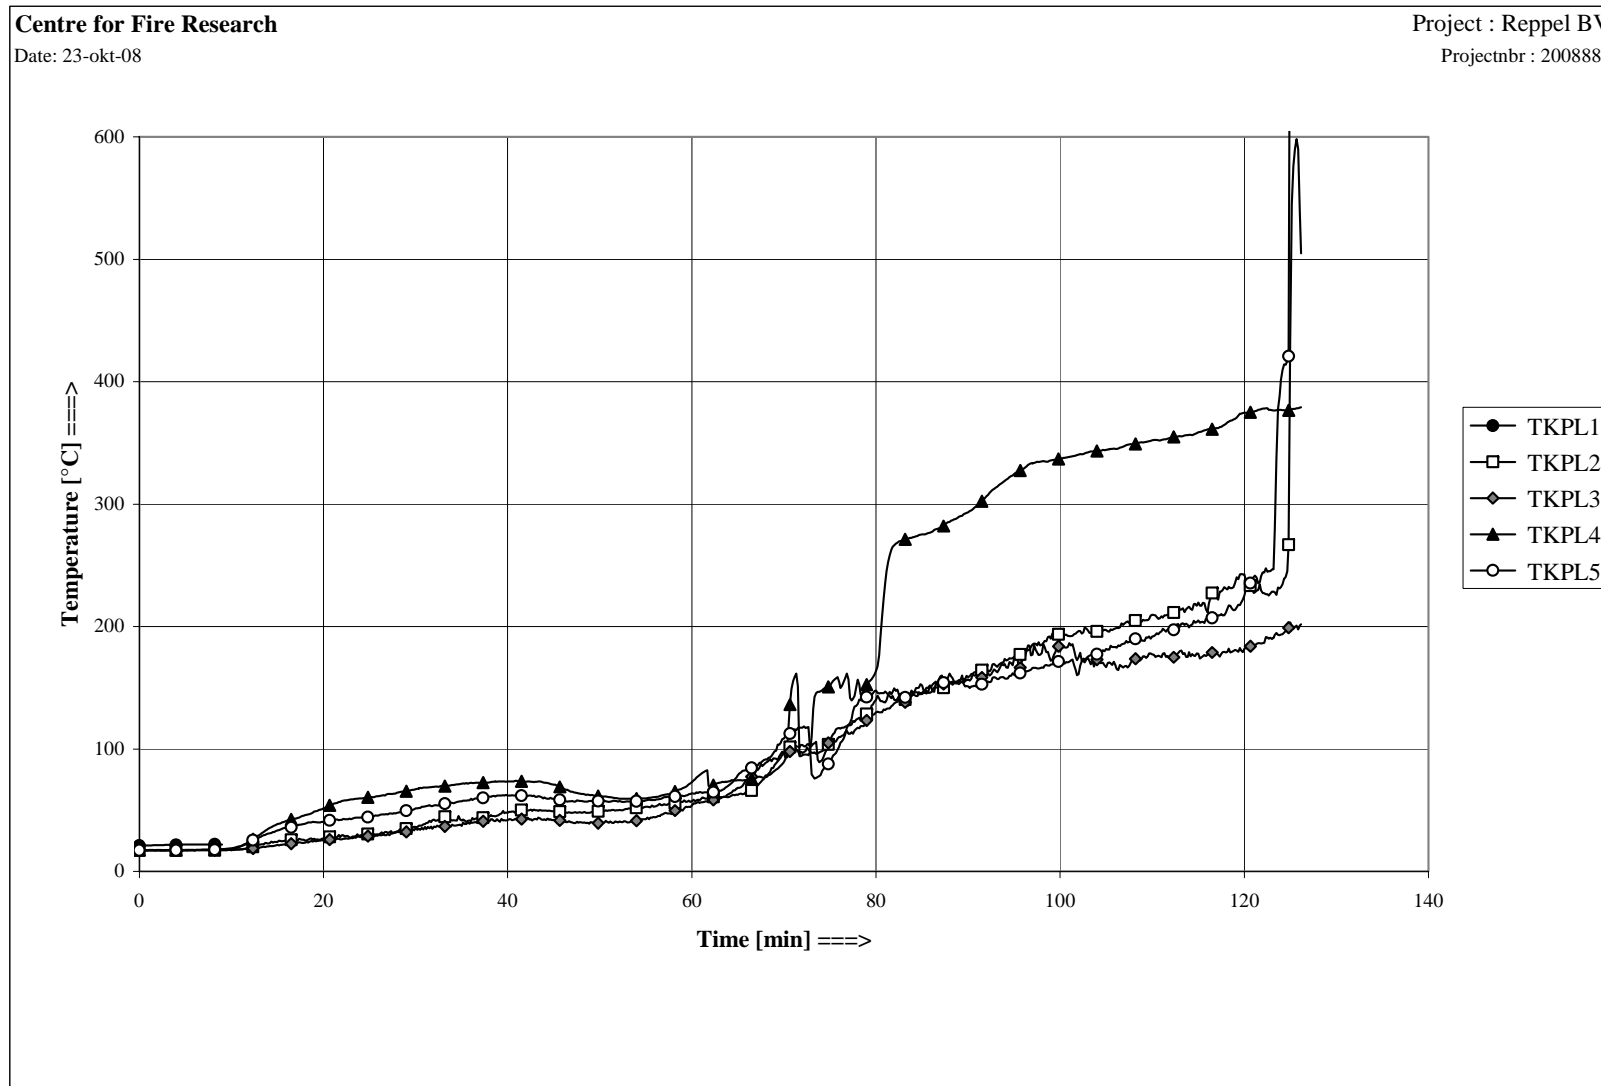
Figure B2: measured air temperatures in the plenum

Figure B2: measured air temperatures in the plenum

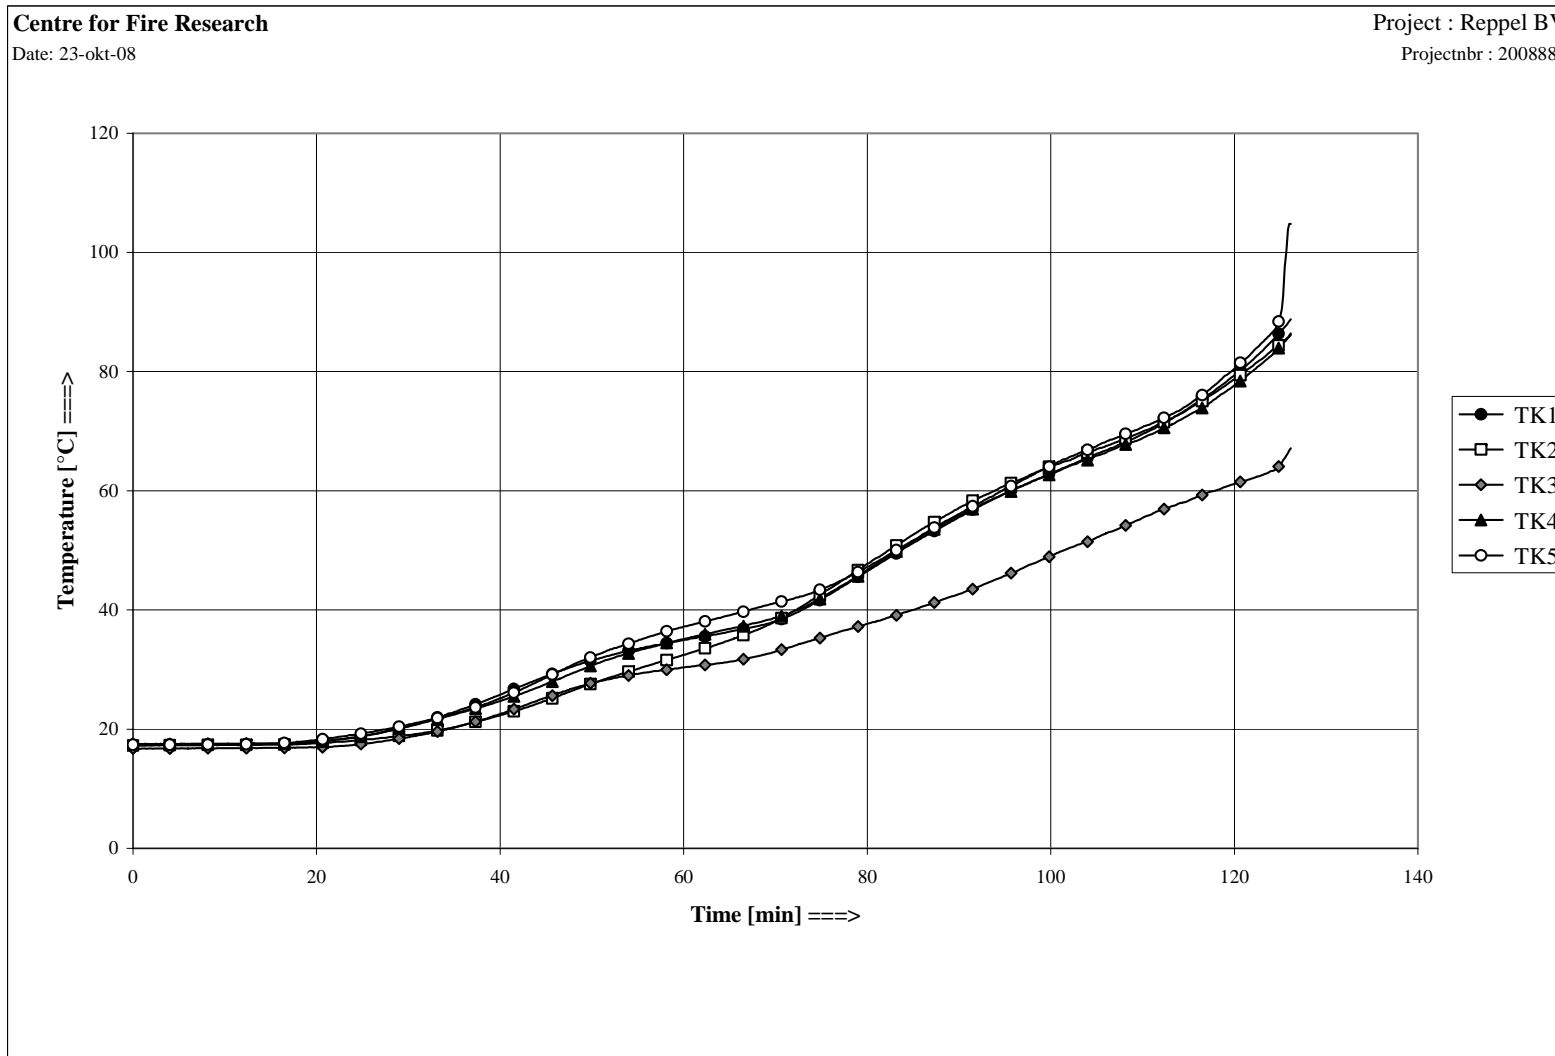
Figure B3: measured surface temperatures on top of the floor

Figure B3: measured surface temperatures on top of the floor

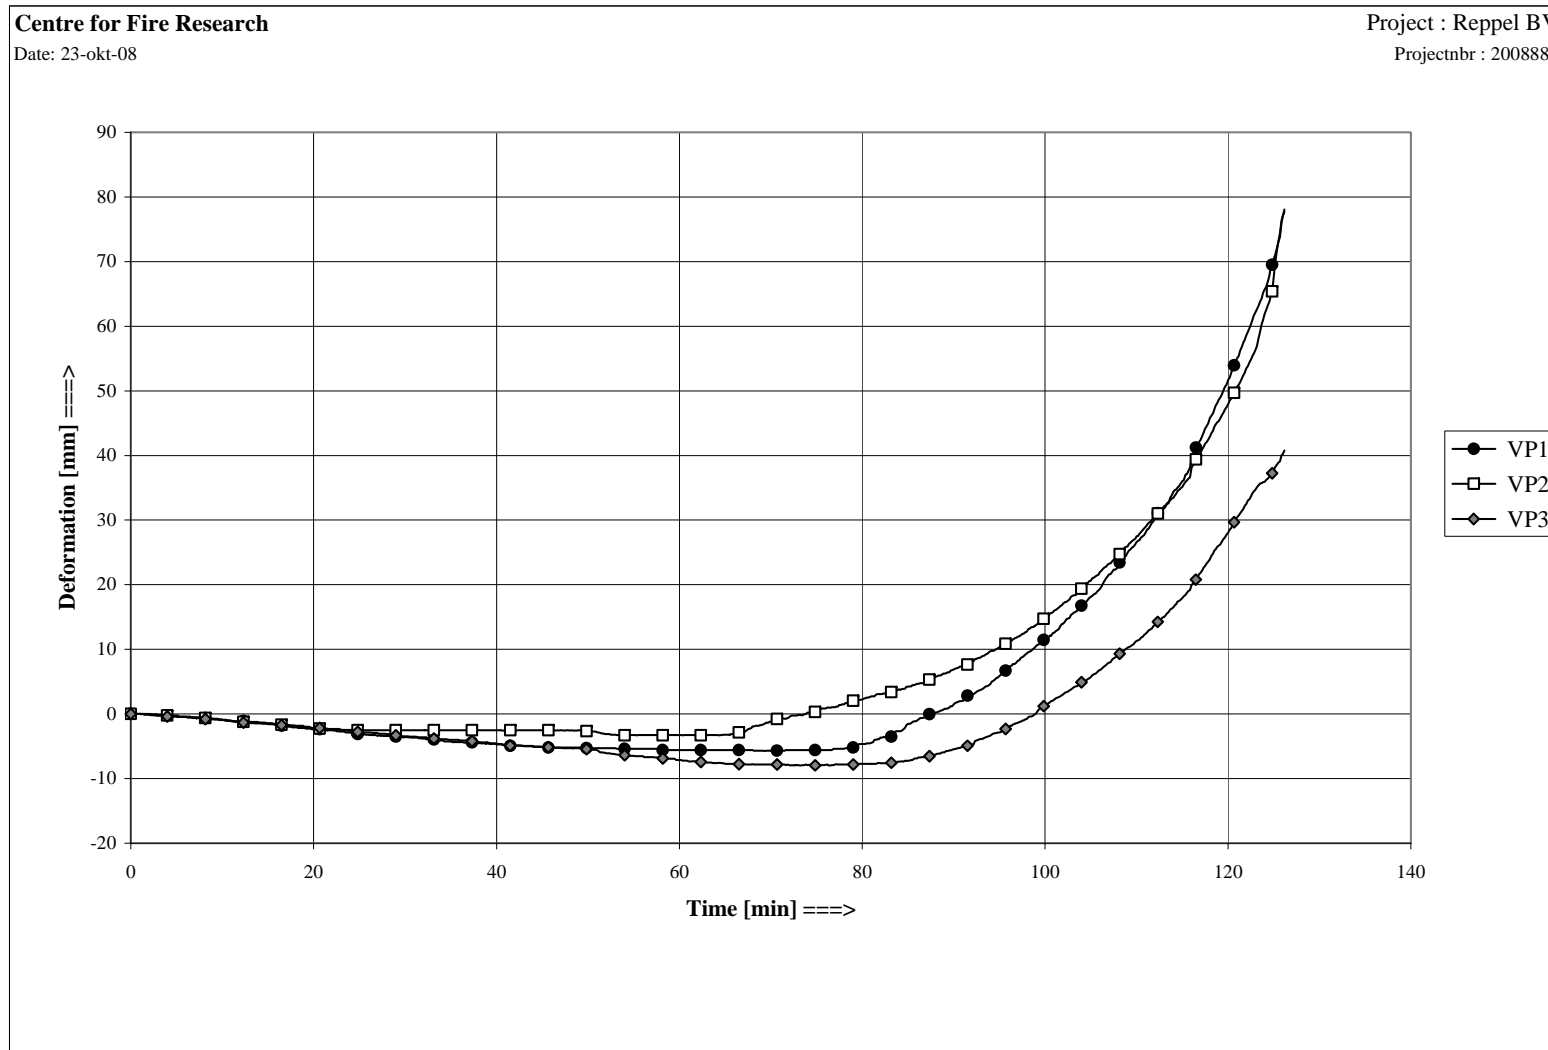
Figure B4: measured deformation of the floor

Figure B4: measured deformation of the floor

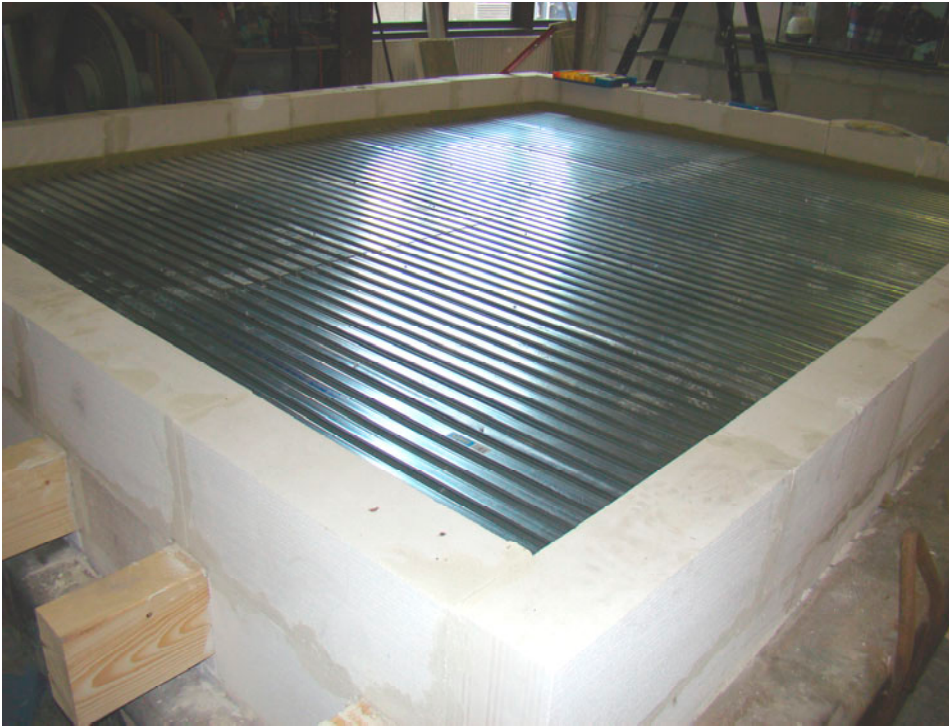
Photo 1: view of the floor before casting the concrete

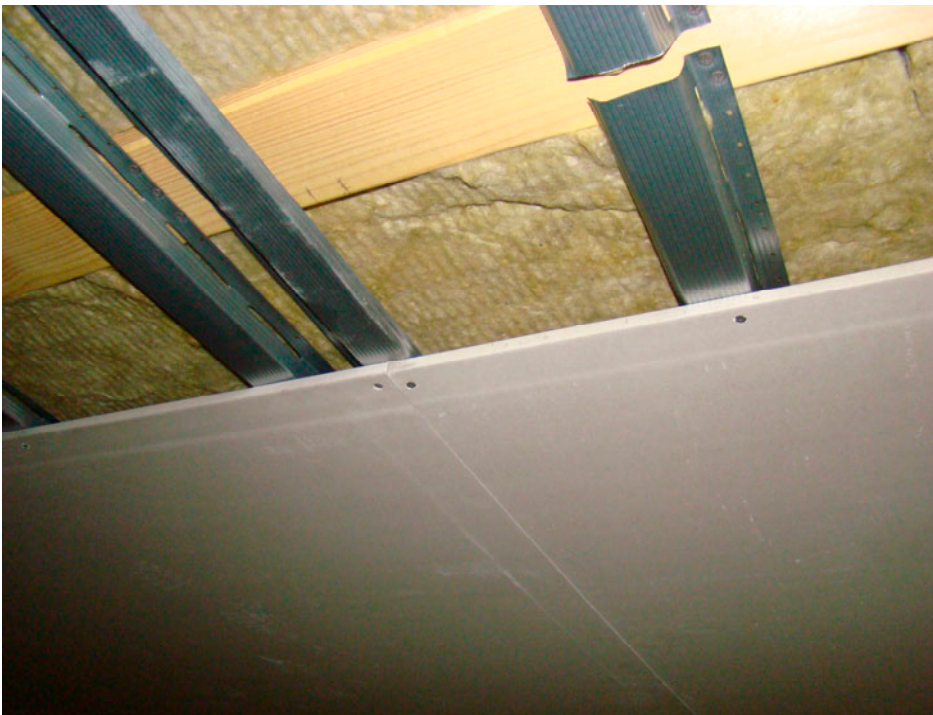
Photo 2 : detail of the mounting of the ceiling channels

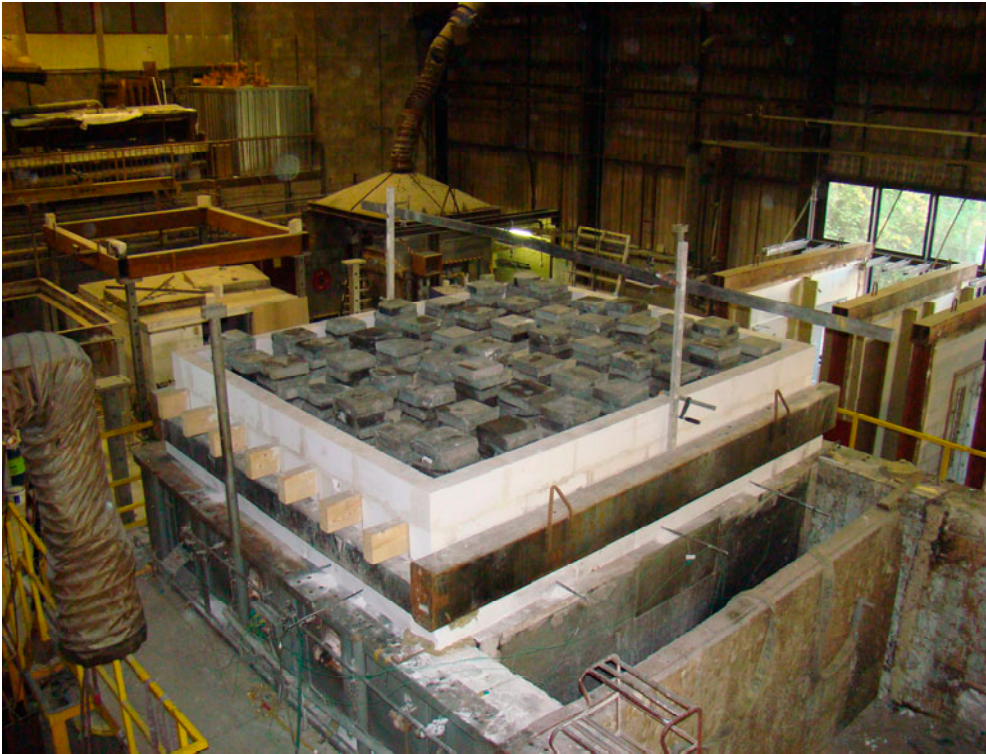
Photo 3 : view of the construction before the test
